**Flood Control Project Maintenance
Levee Inspections**
LMA District Cover Sheet
Spring 2017 Levee Inspection Results

Reclamation District No. 1000 Natomas

Spring 2017 Levee Inspection Results

Waterway			Bank	Unit Miles
Unit No. 01 Sacramento River			Left	18.28
	Spring (March - May)	Summer (June - August)	(September - November) Fall	Winter (December - February)
Unit Maintenance Rating (Fall Only)				
Date of Inspection	3/17/2017 - 3/17/2017			
DWR Inspector	Sterling York			
Accompanied By	Don Caldwell RD1000

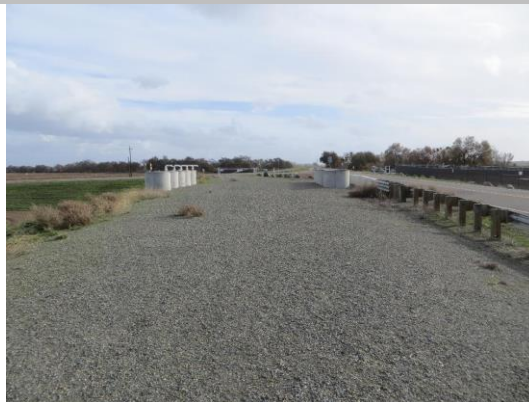
Photo 3 of 3 : UCIP_SP_2017_46972_74879.jpg

LM Start	0.00	Rating **	M	Issue No.	140 (cont)
LM End	0.00	Issue Type +	En	Location *	WS

Risers located on both sides of levee crown.

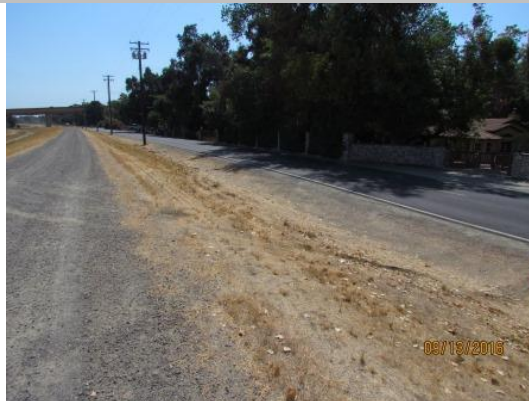
Photo 1 of 1 : SP_2017_RD1000_31_90_20170316_00025.jpg

LM Start	8.11	Rating **	U	Issue No.	90
LM End	8.14	Issue Type +	En	Location *	WS
Category	Earthen Levee			GPS Latitude/Longitude	
				Start	End
Item	Vegetation			38.676425 °	38.676038 °
				-121.627462 °	-121.627063 °
DWR ID	DWR_RD1000_01_s _ 2012_90				
Comment Code					
V6 : Landscaping					
Inspector Comment					
The landscape vegetation prevents the ability to see waterside slope and will make it difficult to access if a flood fight is ever needed.

This photo was taken from the crown facing downstream looking downstream. Landowner maintained vegetation completely block visibility of or access to the levee. Fall 2016.

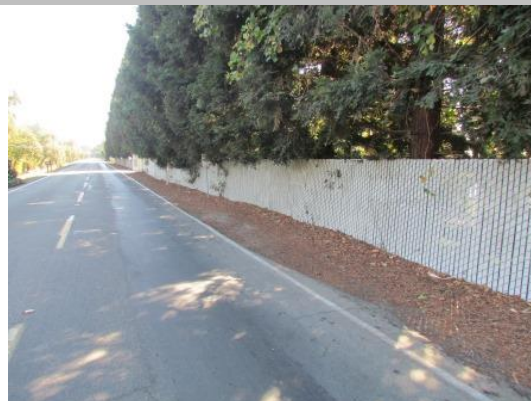
Photo 1 of 1 : SP_2017_RD1000_31_29_20170316_00006.jpg

LM Start	15.49	Rating **	U	Issue No.	29
LM End	15.57	Issue Type +	En	Location *	WS
Category	Earthen Levee			GPS Latitude/Longitude	
				Start	End
Item	Encroachments			38.607207 °	38.606255 °
				-121.555465 °	-121.554582 °
DWR ID	DWR_RD1000_01_s _ 2012_29				
Comment Code					
FE : Fence					
Inspector Comment

This photo was taken from the crown facing downstream looking down the waterward levee slope at an unacceptable fence. Fall 2014.

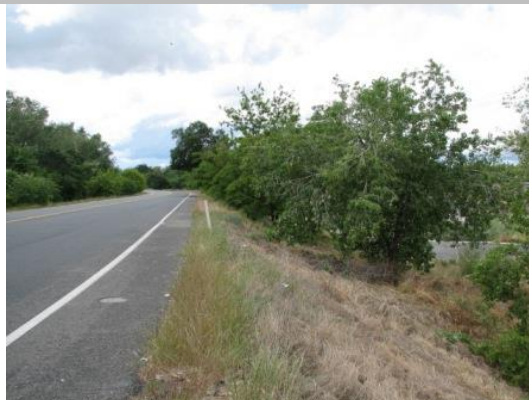
Photo 3 of 3 : SP_2017_RD1000_32_1_20170316_00003.jpg

LM Start	0.56	Rating **	M	Issue No.	1 (cont)
LM End	2.32	Issue Type +	En	Location *	LS

Landside encroachment, landscaping, levee mile 1.68.

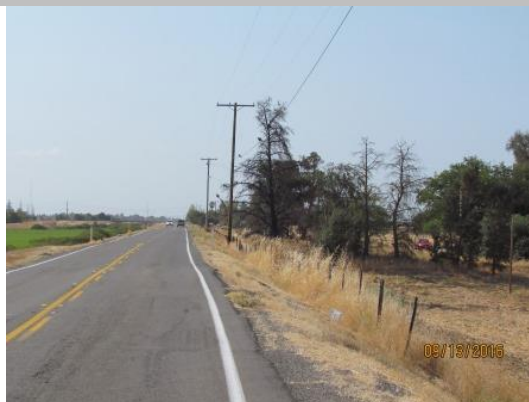
Photo 1 of 1 : SP_2017_RD1000_33_8_20170316_00007.jpg

LM Start	6.27	Rating **	M	Issue No.	8
LM End	6.36	Issue Type +	En	Location *	LS
Category	Earthen Levee			GPS Latitude/Longitude	
				Start	End
Item	Encroachments			38.692847 °	38.694141 °
				-121.485595 °	-121.485596 °
DWR ID	DWR_RD1000_03_f_2015_8				
Comment Code					
FE : Fence					
Inspector Comment					
Fence on landside levee slope.

View of fence on landside levee slope, looking downstream.

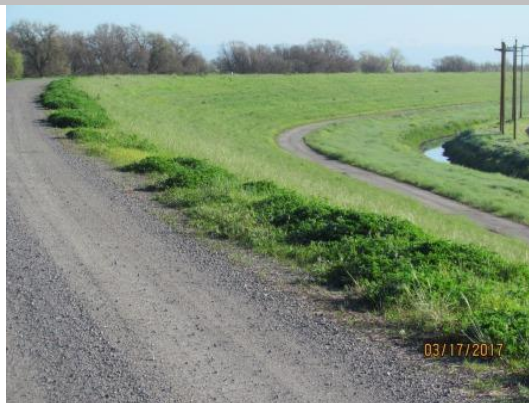
Photo 1 of 1 : SP_2017_RD1000_34_13_20170327_00001.jpg

LM Start	0.00	Rating **	M	Issue No.	13
LM End	4.30	Issue Type +	Ma	Location *	LS
Category	Earthen Levee			GPS Latitude/Longitude	
				Start	End
Item	Vegetation			38.820602 °	38.780516 °
				-121.543824 °	-121.603433 °
DWR ID	DWR_RD1000_04_s_2017_13				
Comment Code					
V1 : Control annual grass and weeds on the levee slopes and easements.					
Inspector Comment					
Annual grass are starting to get a little to tall, the RD has started their spraying, Spring 2017.

View of annual grass land side, that are starting to get a little to tall, the RD has started their spraying, Spring 2017.
